PAWTUXET RIVER BASIN
GLOCESTER, RHODE ISLAND

ONAGANSET RESERVOIR DAM
RI 01304

PHASE 1 INSPECTION REPORT
NATIONAL DAM INSPECTION PROGRAM

MARCH 1980

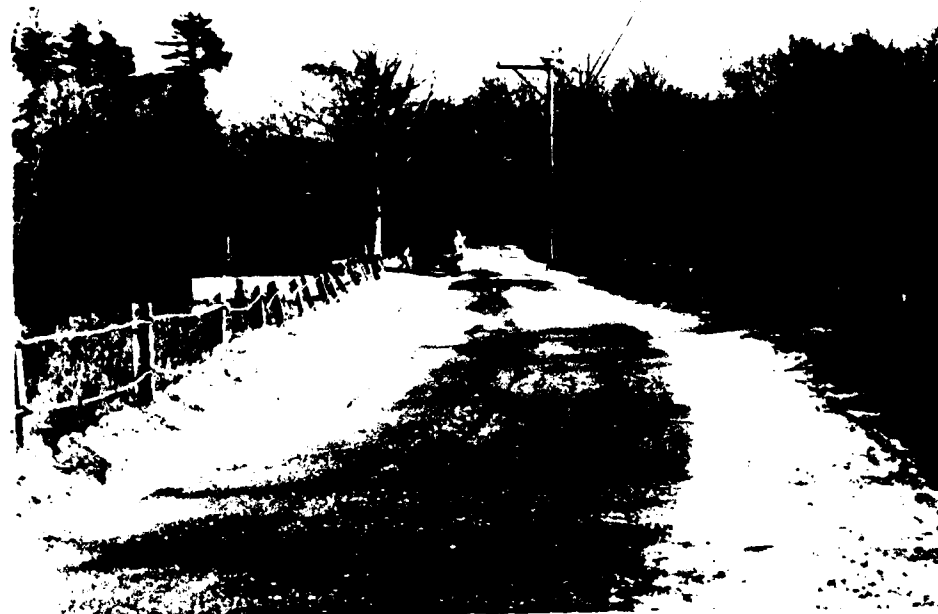
1. Crest - The crest of the dam is approximately 24 feet wide and supports George Allen Road. The pavement of George Allen Road is in need of repair and some erosion of the crest at the edges of pavement has occurred. The guard-rail system which consists of steel post and strung cable is also in need of repair and appears inadequate for present day conditions. Presently the Water Supply Board has added a new catch basin at the edge of the road near the outlet works gate mechanism. In addition, the Providence Water Supply Board has designed, but not constructed, an asphalt berm drainage ditch for George Allen Road to reduce the amount of erosion to the crest of the dam from roadway runoff. (See Photo C-4)

PHOTO C-4 - Crest of Dam looking from Right Abutment.

9. Complete the improvement to George Allen Road.
10. Resolve the differing elevations used by the Providence Water Supply Board on the reservoir documents and the published topography of the U.S. Coast and Geodetic Survey, as used on the Chepachet and Clayville Quadrangles. After resolvment of the discrepancy, re-evaluate the impact to downstream areas from a potential dam failure discharge by developing a downstream profile that will reflect the natural storage areas, flow restrictions and detailed topography.

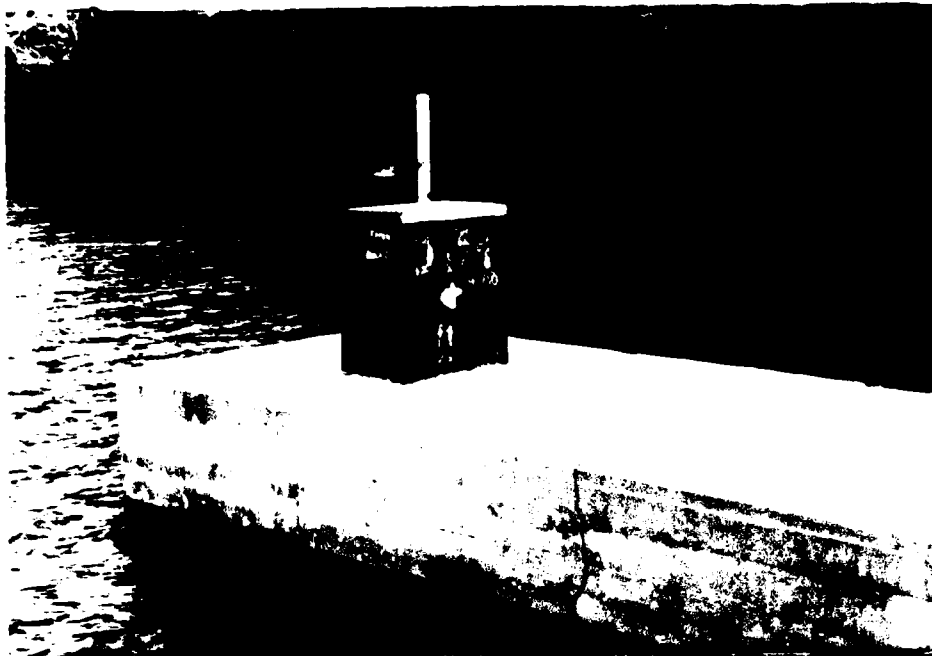
2. Outlet Works - The outlet works at Ponaganset Reservoir is located at Sta 1+55 and consists of a 24-inch cast iron pipe and sluice gate. A concrete pier structure supports the gate mechanism and provides access to the gate from the crest of the dam. The gate mechanism is enclosed within a removable steel locker which provides protection from vandalism. The concrete pier which supports the gate mechanism is cracked and appears to be settling. The gate mechanism was not operated at the time of inspection. The outlet works is leaking, and discussions with the Providence Water Supply Board personnel indicate that the settlement of the pier and leaking outlet pipe may be connected. (See Photos C-5, C-6).

PHOTO C-5 - Outlet works gate control mechanism.

7. Investigate the operability of the sluice gate for the outlet works.
8. Evaluate the cause of the cracked concrete pier which supports the gate mechanism.
